INDOOR AIR QUALITY REASSESSMENT

**Massachusetts Department of Public Health
Division of Health Professions Licensure
239 Causeway Street
Boston, Massachusetts**

Prepared by:
Massachusetts Department of Public Health
Center for Environmental Health
Emergency Response/Indoor Air Quality Program
April 2006

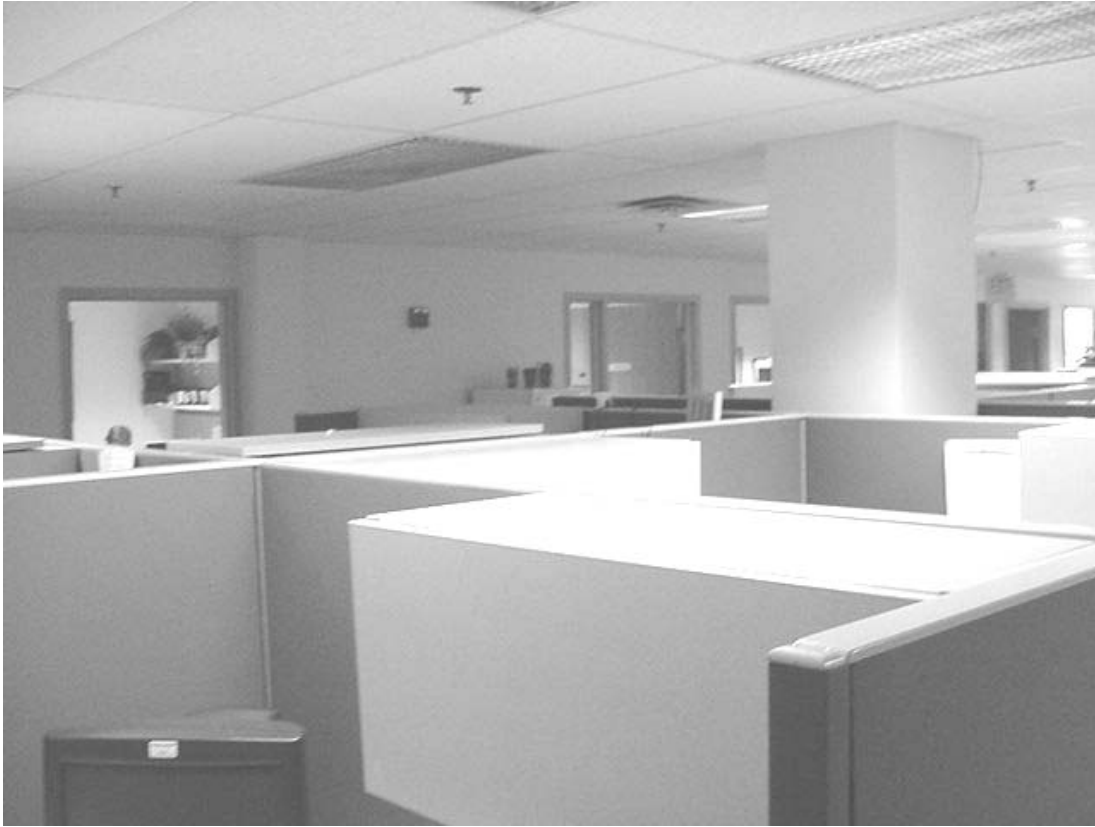
Picture 1

The facility at 239 Causeway Street is a five-story brick office building, originally built as a factory/warehouse in the late 1800's. The DHPL has occupied space on the 4th floor for approximately 5 years. The DHPL floor space consists of perimeter offices and centralized cubicles (Picture 1).

Centralized Cubicles and Perimeter Offices on the 4th Floor

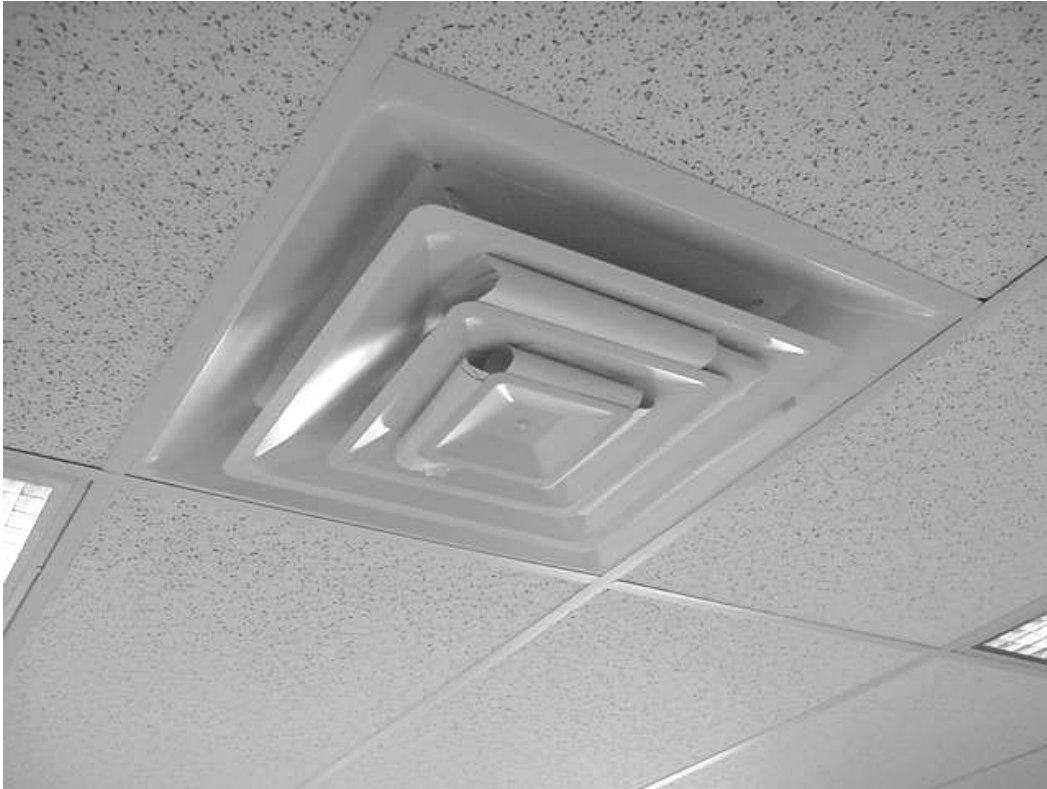
Picture 3

Ceiling-Mounted Air Diffuser, Note Diffuser is Blocked with Paper

1. Set thermostat controls in the fan “on” position to provide continuous air exchange during periods of occupancy.
2. Remove blockages to supply air diffusers (Picture 3).

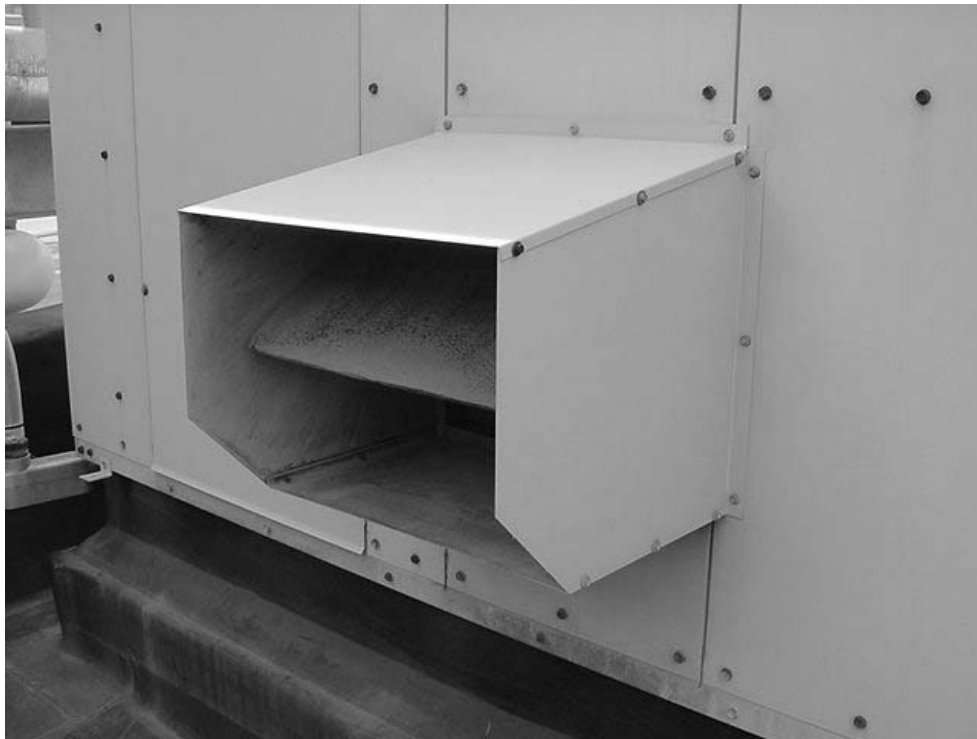
Picture 5

It can be seen from the tables that carbon dioxide levels were above 800 parts per million parts of air [ppm] in all areas surveyed, which is indicative of poor air exchange. Ventilation is provided by a heating, ventilation and air conditioning (HVAC) system. Fresh air is introduced by a rooftop-mounted air-handling unit (AHU) (Picture 2). Heat pumps are located above ceiling tiles to facilitate airflow. Transfer air from the AHU is drawn into the heat pumps and delivered to work stations via ceiling-mounted air diffusers (Picture 3). Exhaust ventilation is provided by drawing air through metal/plastic grates into a ceiling plenum, which returns air to the AHUs where it is exhausted (Picture 5).

Exhaust Vent on Rooftop AHU

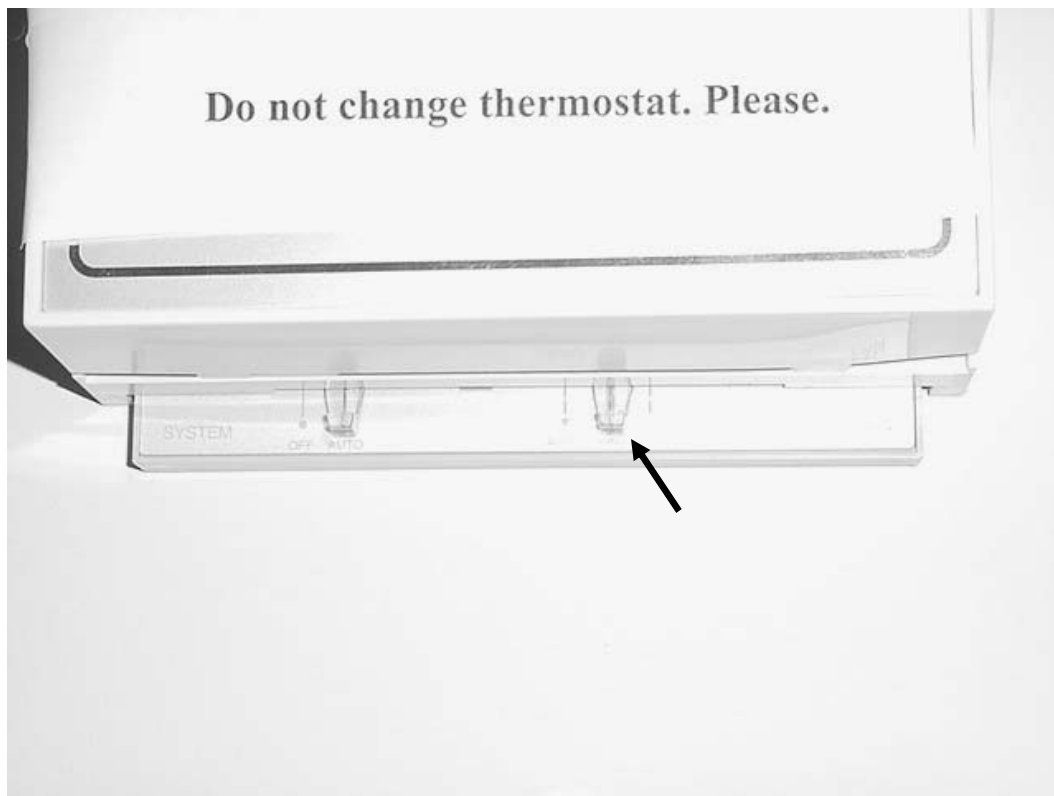
Picture 7

The ventilation system is controlled by mercury-switch thermostats (Picture 6). Thermostats have a fan switch, which can be set to either “auto” or “on”. The “automatic” setting on the thermostat activates the ventilation system at a preset temperature. Once the preset temperature is reached, the system is deactivated. Therefore, no mechanical ventilation is provided until the thermostat re-activates the system. At the time of the assessment, switches were set to the fan “auto” setting (Picture 7).

HVAC Thermostat, Note Fan in “Auto” Position

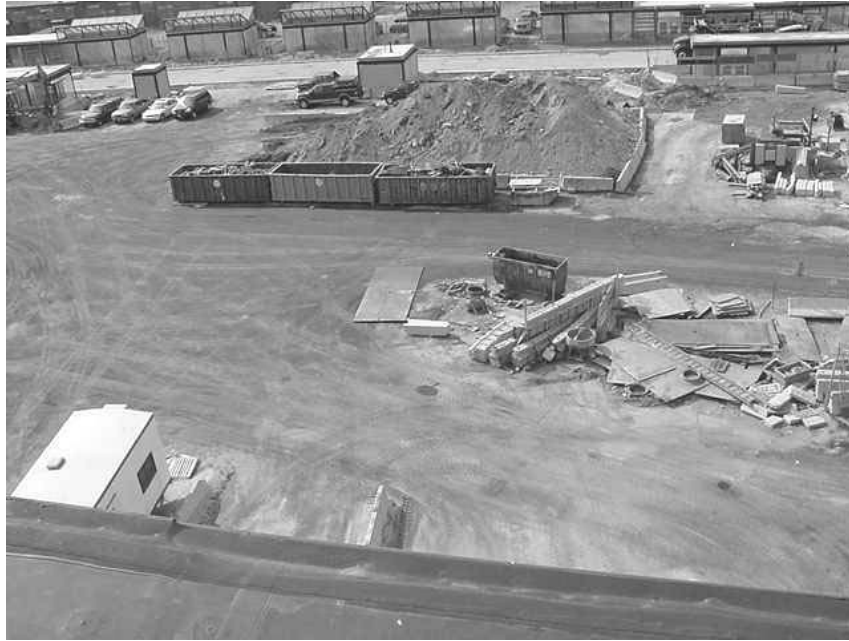
Picture 9

MDPH staff inspected the HVAC system for filtration, which is provided by dual filtration. The rooftop AHU is equipped with high efficiency-pleated filters (Picture 8), which removes airborne particulates at the source. Air is then distributed to localized heat pumps throughout the space, where they are filtered a second time prior to being distributed via air diffusers. Mr. Pyne reported that filters are changed every two weeks due to construction activity adjacent to the building (Picture 9).

Construction Activity Adjacent to 239 Causeway Street

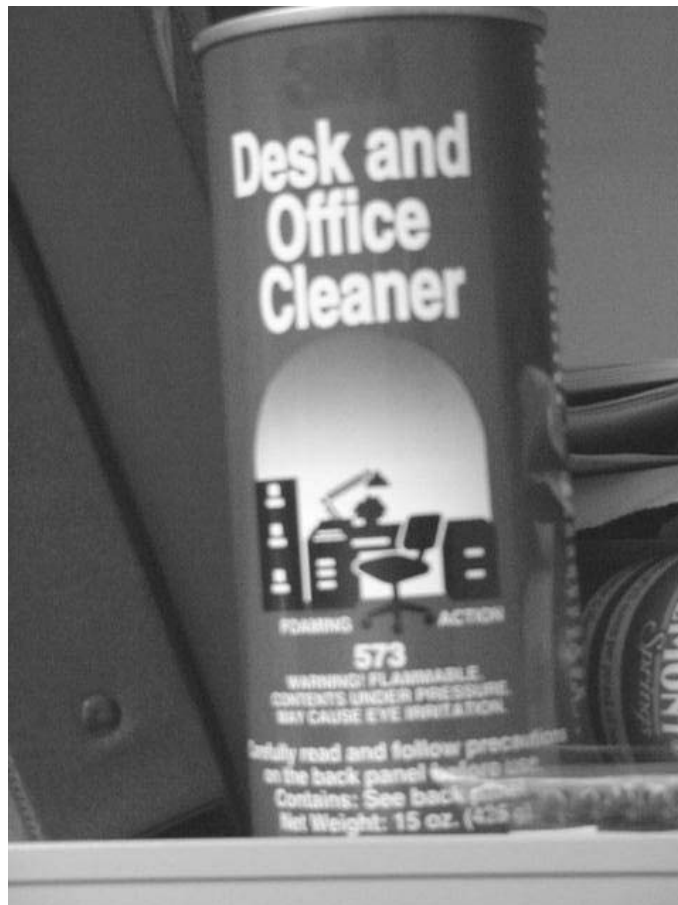
Picture 10

Lastly, DHPL staff frequently use VOC-containing cleaning materials (Pictures 10 and 11) to clean their personal work areas. These materials contain several VOCs (e.g., isopropyl alcohol and monoethanolamine) that can be irritating to the eyes, nose and throat (3M, 2000).

Spray Office Cleaner, Note Label “May Cause Eye Irritation”

8. Discontinue the use of VOC-containing cleaners. Less irritating materials, (soap and water) may suffice to clean in these areas.
9. Clean supply and return diffusers periodically of accumulated dust.
10. Continue with plans to replace carpeting in DHPL space.
11. Consider cleaning carpeting annually (or semi-annually in soiled high traffic areas) as per the recommendations of the Institute of Inspection, Cleaning and Restoration Certification (IICRC). Copies of the IICRC fact sheet can be downloaded at:
http://www.cleancareseminars.com/carpet_cleaning_faq4.htm (IICRC, 2005)

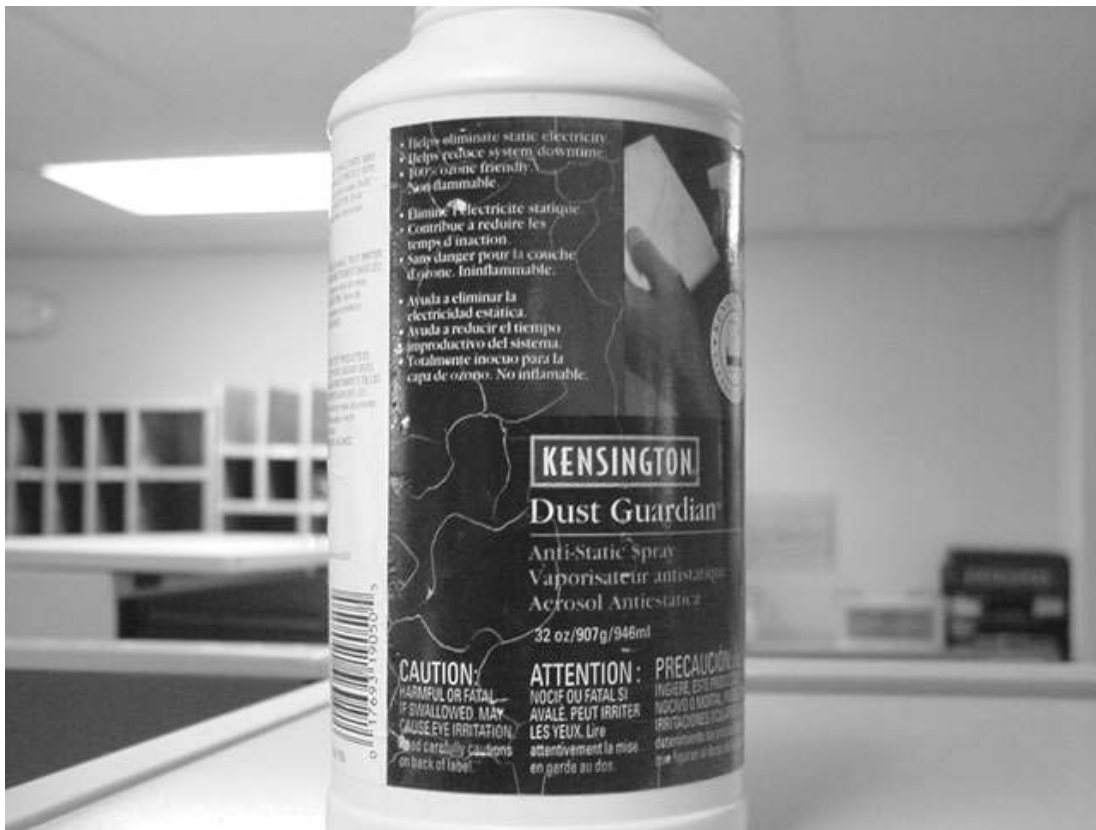
Picture 11

Spray Office Cleaner, Note Label “May Cause Eye Irritation”
